Manhole Inspection Summary

Manhole # S25II1010MH

Insp Date: **12/12/06 12:27 PM**

Location Address: **4100 EVANS CHAPEL RD**

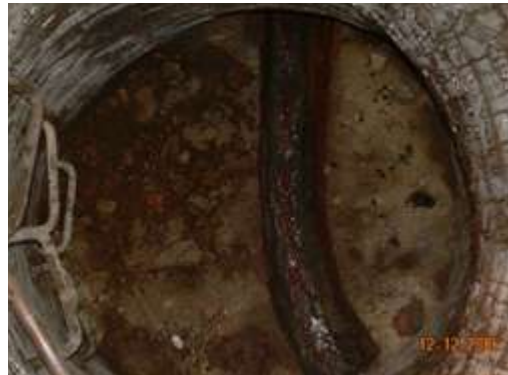
Top View

Barrel infiltration. Bench debris.

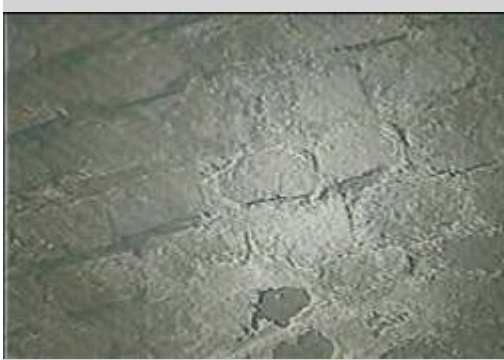
Defect

Condition: ☐ Sound ☐ Cracked ☐ Root Intrusion ☐ Loose Brick ☒ **Deteriorated**

Infiltration: ☐ None ☐ Joint ☐ Cracks ☒ **Mortar** ☐ Roots ☐ Wall

Barrel deterioration and infiltration.

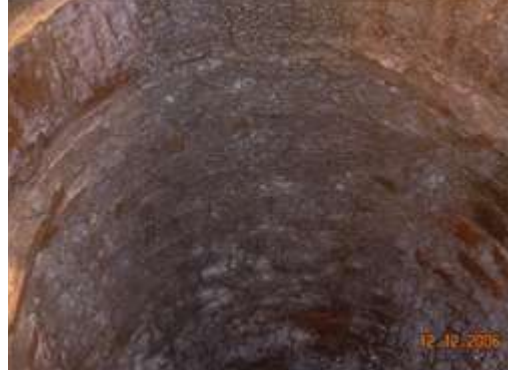
Defect

Frame Offset: **1** (in.) Condition: ☐ Sound ☐ Cracked ☒ **Leaks**

Infiltration: ☐ None ☒ **Joint** ☐ Cracks ☐ Mortar ☐ Roots ☐ Wall

Frame leaks. Adjustment infiltration.

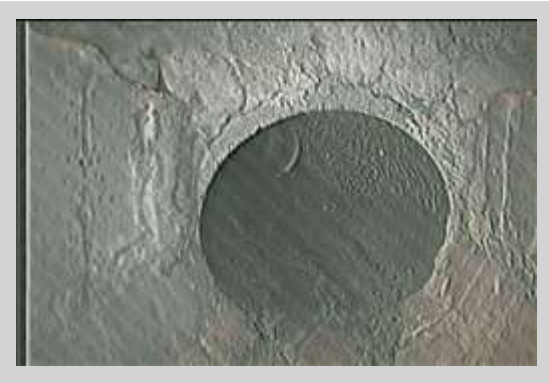
8 in. Circular Gravity Sewer Pipe Out @ 12 O'Clock

Infiltration: **Evidence** Pipe Seal Cond: **Cracked**

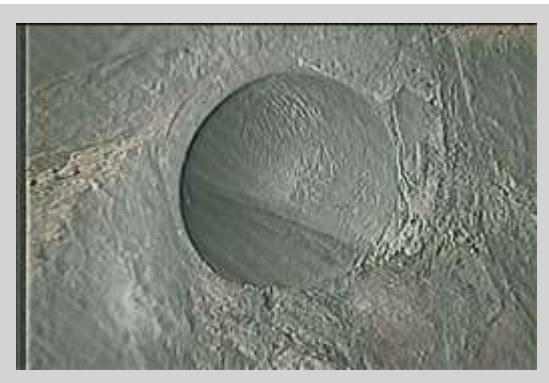
8 in. Circular Gravity Sewer Pipe In @ 5 O'Clock

Infiltration: **None** Pipe Seal Cond: **Unknown**
